Manhole Inspection Summary

Manhole # S21YY1011MH

Insp Date: **4/5/07 11:28 AM**

Location Address: **5409 FALLS RD TERR**

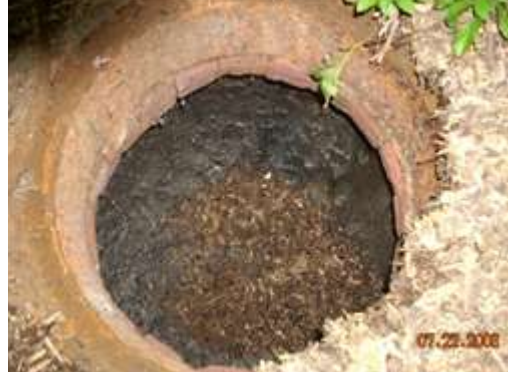
Top View

Evidence of surcharge - Bench debris.

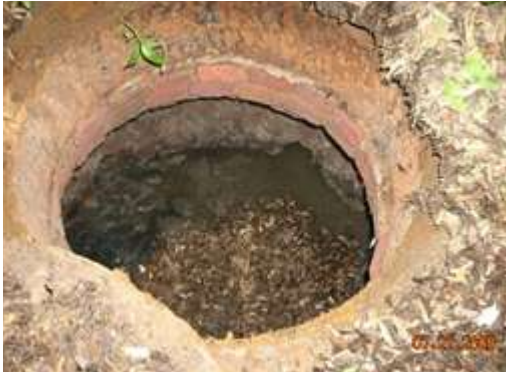
Defect

Frame leaks. Corbel deterioration and infiltration - other side.

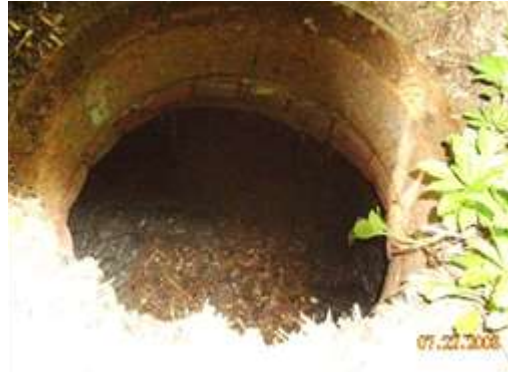
Defect

Frame leaks. Corbel deterioration and infiltration.

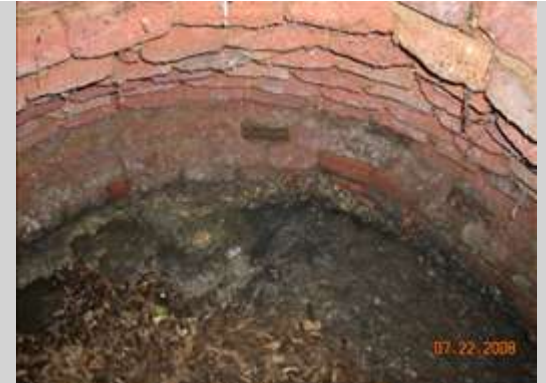
6 in. Circular Gravity Sewer Pipe Out @ 12 O'Clock

Barrel infiltration.

Deposits: ☐ None ☒ **Mud** ☐ Sludge ☒ **Debris** ☐ Grease

Silt Depth: **5** (in.) Deposits Extent: **Heavy**

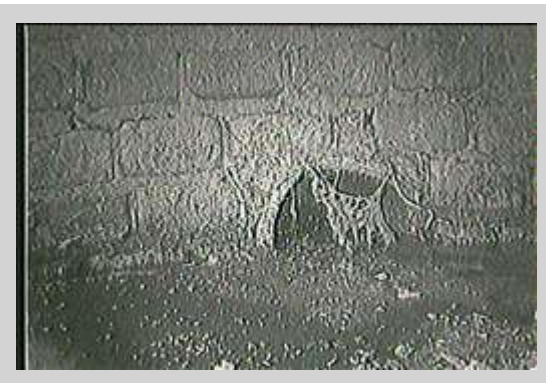
6 in. Circular Gravity Sewer Pipe In @ 6 O'Clock

Deposits: ☐ None ☒ **Mud** ☐ Sludge ☒ **Debris** ☐ Grease

Silt Depth: **2** (in.) Deposits Extent: **Medium**

Infiltration: **None** Pipe Seal Cond: **Roots**

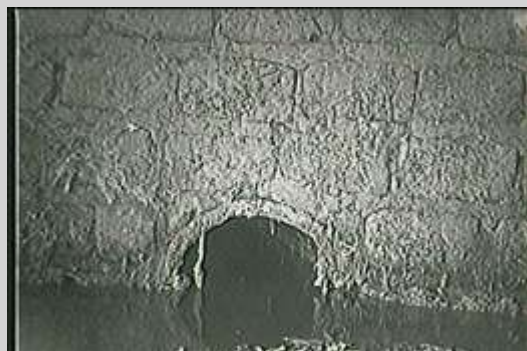
Pipe In @ 9 O'Clock

Barrel root intrusion and infiltration.

Deposits: ☐ None ☒ **Mud** ☐ Sludge ☒ **Debris** ☐ Grease

Silt Depth: **2** (in.) Deposits Extent: **Medium**

Pipe Seal Cond: **Roots**
